EASA CS ADR-DSN.E.360

Sklony na odbavovací ploše JIH

EASA ADR-DSN.E.360 Slopes on APN SOUTH

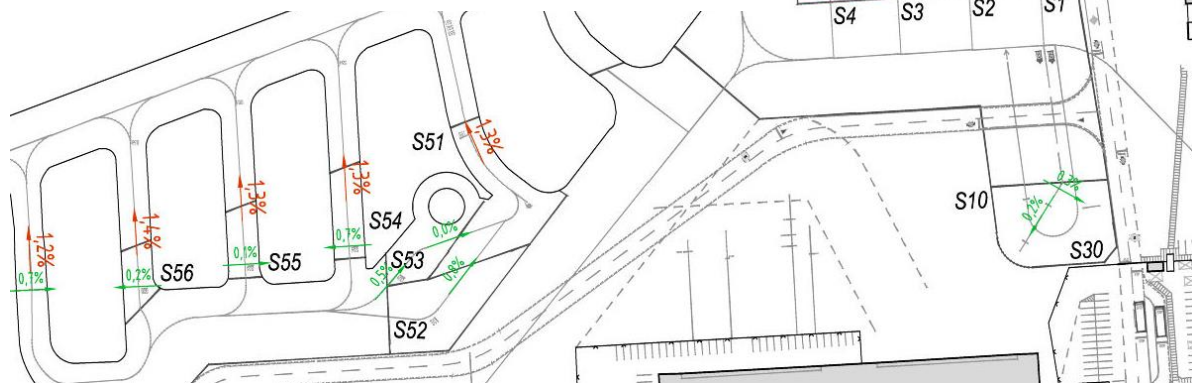
Odbavovací plocha JIH má známou zvláštnost. Podélné sklony jsou značně větší, než požaduje předpis. Dosahují hodnot 1,4 %, 1,8 % a 2,4 % a nelze je snížit z důvodu návaznosti na okolní TWYs a hangáry. Negativní vliv na bezpečnost dosud nebyl zaznamenán.

Apron SOUTH has an unusual attribute.

Longitudinal slopes are considerably larger than permitted, reaches 1.4%, 1.8% and 2.4%.

Reduction is not possible because of the surrounding TWYs and historical hangars. Negative impact on safety has not been recorded.

Upozornujeme na nutnost důsledného zabezpečení letadel a mobilních prostředků proti samovolnému pohybu.

Keep in mind the need of protection of aircraft and GSE against accidental movement.
