Aircraft ground damage caused by jammed locks of LDL Trepel Champ 70

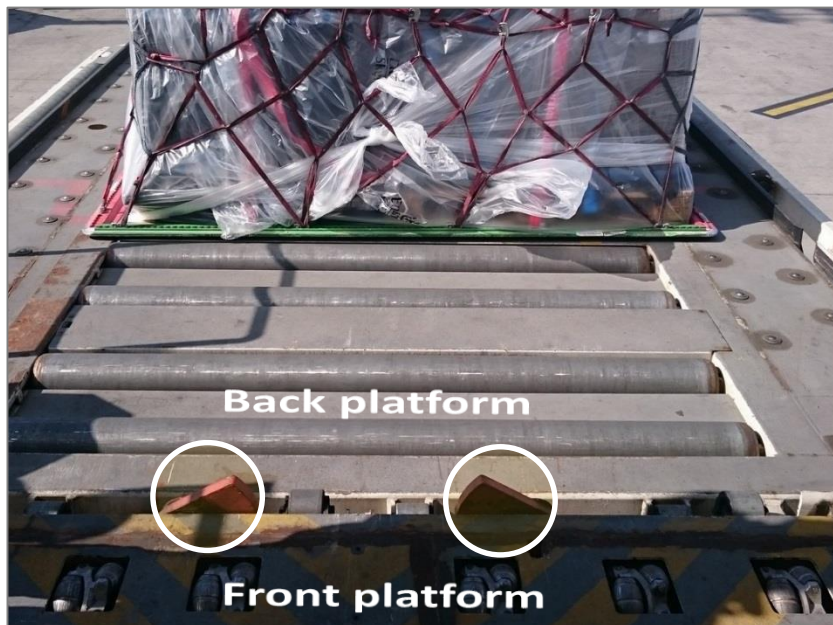
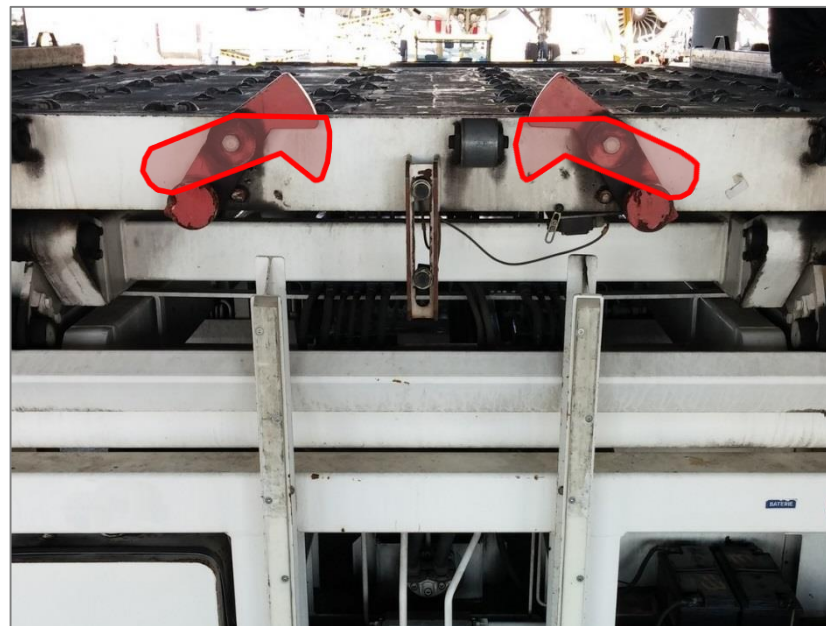
We have recently recorded a minor damage of aircraft caused by the jammed locks of the front platform of LDL:

„As back platform has been travelling up, the front platform suddenly started to move upwards as well for no obvious reason. Operator used the emergency stop button as soon as he realized what is going on, but meanwhile the siderail on the edge of the front platform got into contact with the opened hatch of the door control panel and distorted it. Fortunately no one was injured.“

If you have noticed or recorded similar malfunction caused by the jammed locks of LDL, speak up, please!
